Australian Government
Department of Defence
Defence Science and
Technology Organisation

Results from Preliminary Checks on AmBe Neutron Source #71

Arthur Eleftherakis and Martin Kocan

DSTO-TN-1003

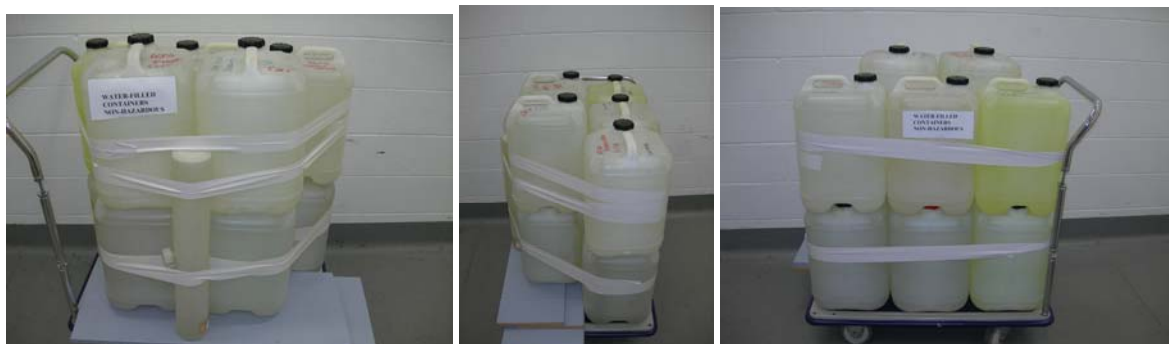
Figure 2. Water-filled containers or “wall of water” mounted on a mobile trolley (the left photo shows a view of the 2 x 2 front layer along with the cylindrical container; the centre photo shows a side view of the front and rear layer; the right photo shows a view of the 2 x 3 rear layer)

To reduce the neutron radiation level, ten water-filled containers and an additional water-filled cylindrical container were arranged to construct what is referred to in this report as a “**wall of water**”. Each container had dimensions of 28 cm x 28 cm x 38 cm. The cylindrical container had dimensions of 60 cm length and 10 cm diameter. The wall of water shown in Figure 2 consisted of two layers. The rear layer behind which personnel would stand had 2 x 3 containers (6 containers in all) and the front layer which was nearest to the neutron source had 2 x 2 containers (4 containers in all) and the additional water-filled cylindrical container. The water-filled containers were placed on a mobile trolley and tied closely together using cloth tape to minimise air gaps between adjacent containers. The front layer of containers (nearest the source) was offset both vertically and horizontally to maximise overlapping and ensure there were no line-of-sight air gaps between the rear and front wall layers. This meant there was at least 28 cm of water shielding around the edges of the containers but up to 56 cm of water towards the centre of the containers. Minimising air gaps and maximising the amount of water neutrons had to travel through would assist in attenuating the number of neutrons passing through the wall of water and minimising the neutron dose to personnel. The half-thickness of water for 4 MeV neutrons is 5.4 cm (reference 7). Therefore, 28 cm of water (equivalent to approximately 5 half-thicknesses) will reduce the neutron dose rate by a factor of 32 and in cases where the water is up to 56 cm thick (equivalent to approximately 10 half-value thicknesses) the neutron dose rate will be reduced by a factor of 1024. The actual neutron dose rate penetrating through the wall of water will be measured using the Meridian Model

5085 neutron meter to ensure the neutron levels are low and that doses received by personnel do not exceed dose limits discussed in section 4.1.

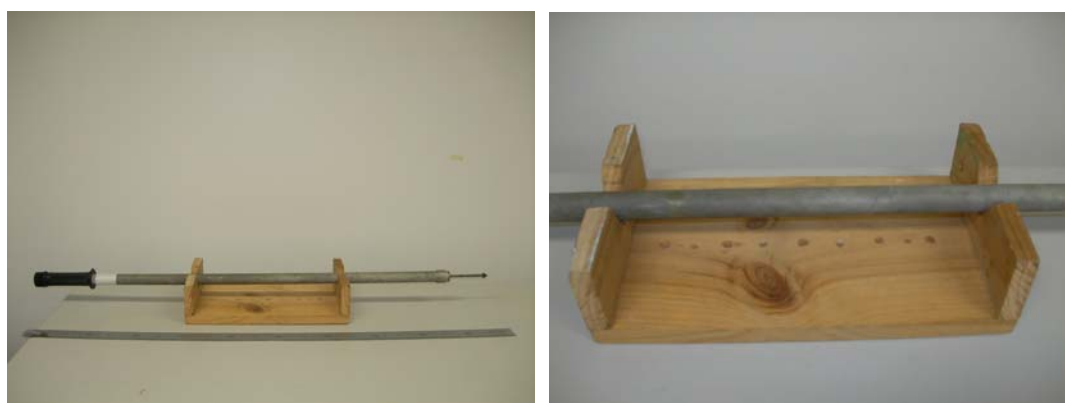
Figure 3. Neutron source handling rod and wooden frame with V-shaped cut-outs

Figure 3 shows the 1 metre neutron source long handling rod and a wooden frame with V-shaped cut-outs for supporting the handling rod on the left. One end of the neutron source handling rod has a threaded end for attaching to the AmBe neutron source. On the right in Figure 3 is a close up of the wooden frame with the V-shaped cut-outs.

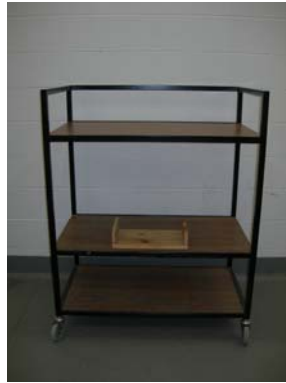
Figure 4. Metal-frame trolley

A metal-frame trolley shown in Figure 4 was used to construct an improvised setup for holding the neutron source and performing the wipe-testing.

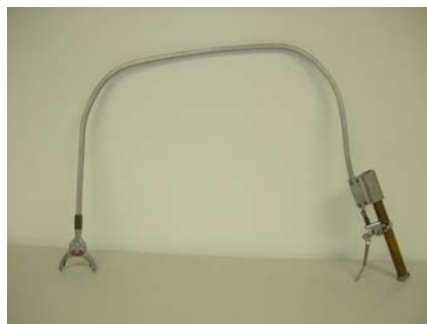
Figure 10. U-shaped remote handling tool

Figure 10 shows a U-shaped remote handling tool that was used to perform wipe testing. This handling tool was ideal as it allowed an operator to wipe the AmBe neutron source from behind the safety of the wall of water shielding. The operator used an angled mirror attached to the top of the metal-frame trolley (see Figure 7) to view the source while wiping it.

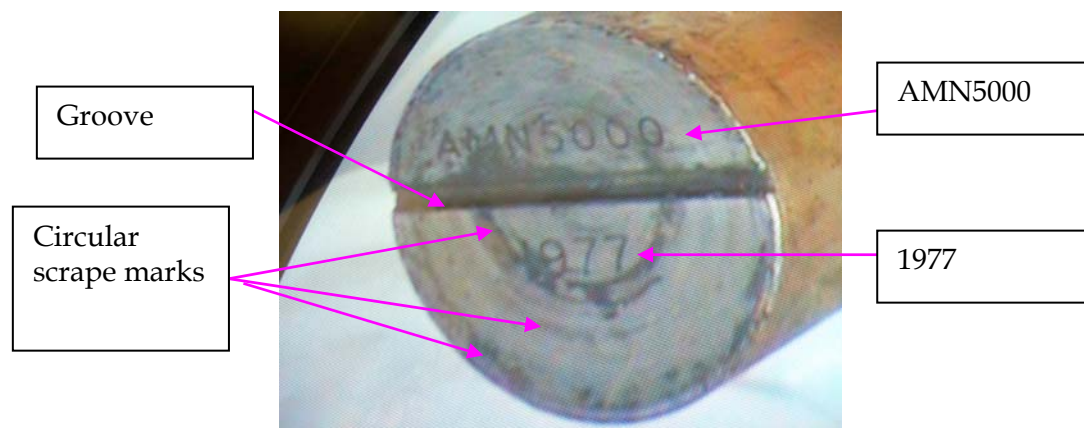
Figure 16. Markings on bottom of AmBe source

AMN5000
1977

The year 1977, is most likely the year of manufacture of the source. This is supported by the fact that available records indicate this source was acquired by DSTO during Feb 1978. From the Amersham catalogue² of 1977/8, it is known that AmBe source capsules with an activity of 5 Ci had a product code "AMN.23". Amersham used the descriptor prefix "AMN" to indicate the product codes for its entire AmBe neutron source range. The origin or meaning of AMN5000 on the DSTO AmBe source is not known. In figures 11-13, there is a groove cut into the bottom end of the source capsule, along the entire diameter of the source. In the Amersham catalogue of 1977/8, the "AMN.23" AmBe sources were normally supplied with only a small 2mm slot at the centre. It is possible that the AMN5000 is a unique product code for the customised source capsule acquired by DSTO. Another possibility is it may refer to the 5000 mCi (i.e. 5 Ci) activity of the source.
